Fatigue Behavior and Failure Mechanisms  
of Centrally Notched  $[0]_s$  and  $[(0/90)_2]_s$   
Silicon Carbide Reinforced  
Aluminosilicate Glass

THESIS

Presented to the Faculty of the School of Engineering  
of the Air Force Institute of Technology  
Air University

In Partial Fulfillment of the  
Requirements for the Degree of  
Master of Science in Aeronautical Engineering

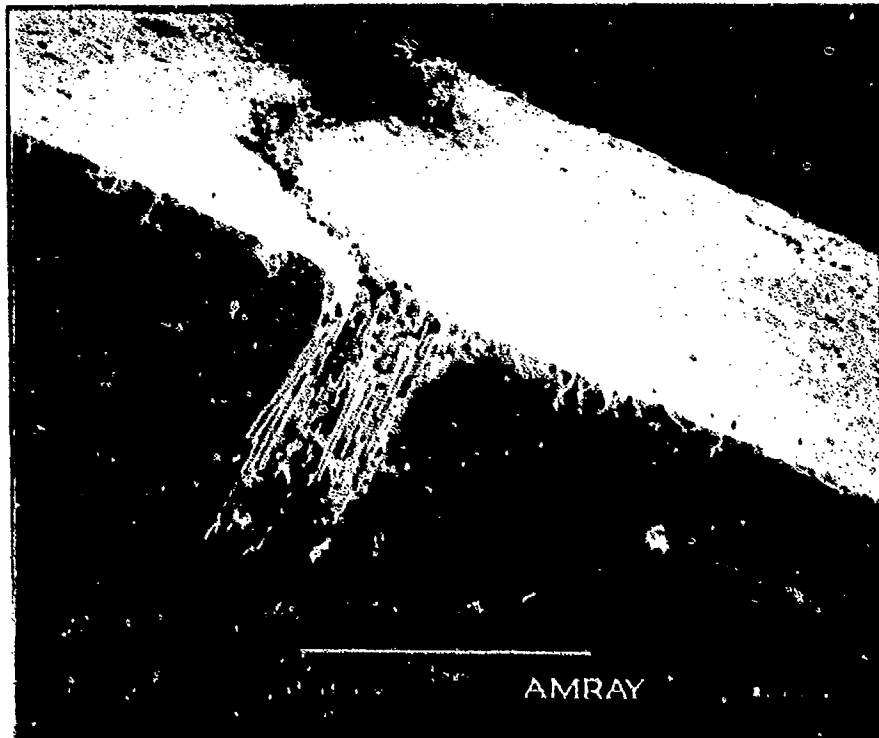
SEM photographs of this specimen were taken to verify the C-Scan results of the earlier test. The author wanted to examine the crack in Specimen 90G0701 where failure did not occur. This would be the lower crack extending to the left in figure 33. This crack appears as a surface matrix crack. It was necessary to microscopically show that the crack extended through the thickness and was not confined to the top matrix layer. The cracks on opposite sides of the specimen were not identical so it could not be assumed that the crack was through the thickness. Figure 34 is an SEM photograph taken looking down into the hole. In the left portion of the figure, the surface longitudinal matrix crack is visible, with intact fibers below it. However, as can be seen, the matrix crack extends through the hole as predicted earlier. The specimen was then cut in half several millimeters below the hole. Figure 35 is an SEM photograph of one of the cut surfaces. It is obvious in the figure that the matrix crack has extended totally through the thickness. The somewhat random path of the crack accounts for the different crack appearances on opposite sides of the specimen.
